RE: Request for Information (“RFI”) Pursuant to Section 308 of the Clean Water Act
CTS Dairy, LLC Concentrated Animal Feeding Operation (NYA000253)
Docket No. CWA-IR-16-031

CAFO COMPLIANCE INSPECTION REPORT

Inspection Date: July 26, 2016 Inspection Time: 0900 - 1330	Inspector: Christy Arvizu, Environmental Scientist USEPA Region 2, (212) 637-3961
Weather Conditions: Sunny/Partly Cloudy	Temperature (°F): between 72 - 90
Inspection Type: Compliance Evaluation Inspection	
On-Site Representatives: Charles Eastman, Partner/Owner, CTS Dairy, LLC (315) 486-1389	
Other Attendees: Christine Watkins, Certified CNMP Planner, Executive Director Jefferson County Soil and Water Conservation District (315) 782 – 2749; Brian Boyer, Inspector, NYSDEC Region 6, (315) 785 – 2518; Patrick Whalen, Life Scientist, USEPA, Region 2, (212) 637-4290	
CTS Dairy, LLC Site Information:	
Main Farm 10798 NYS Route 193 Ellisburg, New York 13636	Machold Road Heifer Facility Machold Road south of intersection with Chamberlain Road Ellisburg, New York 13661
NPDES/ICIS No.: NYA000253 SPDES General Permit No. GP-04-02	
SIC/NAICS Code: 0291/112990 (General Farms)

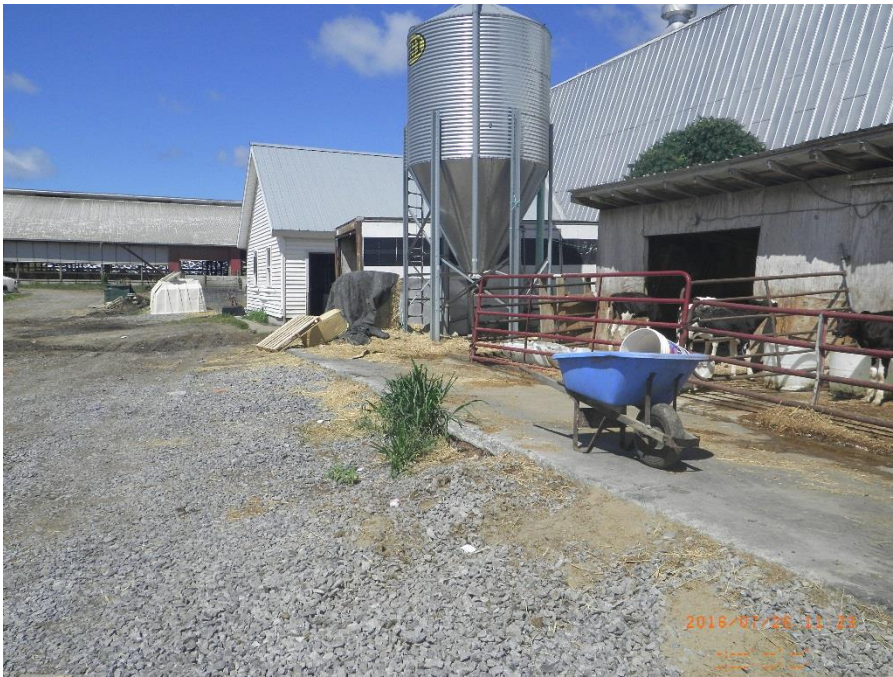
Generally, all animals are housed within the barns with limited exposure to precipitation, with the exception of calf hutches located to the east of the Heifer Barn and super hutches located immediately adjacent to and south of the Old Barn at the Main Farm. Feed residue from the super hutch area runs off into a catch basin at the west end of the concrete pad. The catch basin flows to the Old Barn reception pit which is connected to pump house #1 and eventually pumps to the manure storage.

Photo #1 – Calf Super Hutch Area; view looking west

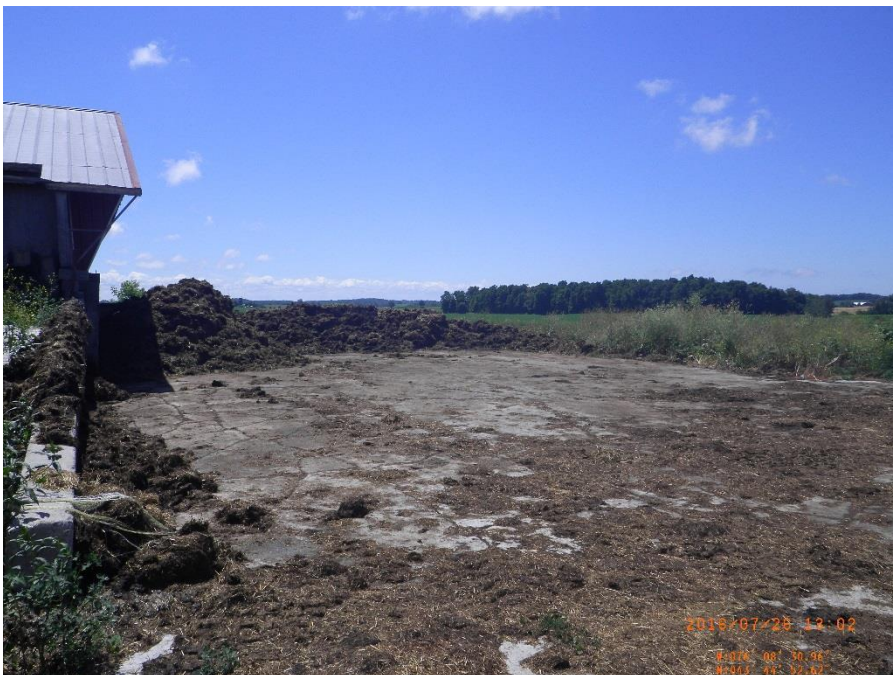
All animals at the Machold Road Heifer Facility are housed within the barn and there is no outside exposure. At the time of the inspection, EPA Inspector Arvizu observed semi-solid manure stored outside on the concrete pad to the west of the barn that would be exposed to precipitation. Run-off from the concrete pad would flow to adjacent fields. EPA Inspector Arvizu observed there are no nearby waters of the United States.

Photo #2 – Machold Road Heifer Facility manure stacking area; view looking south

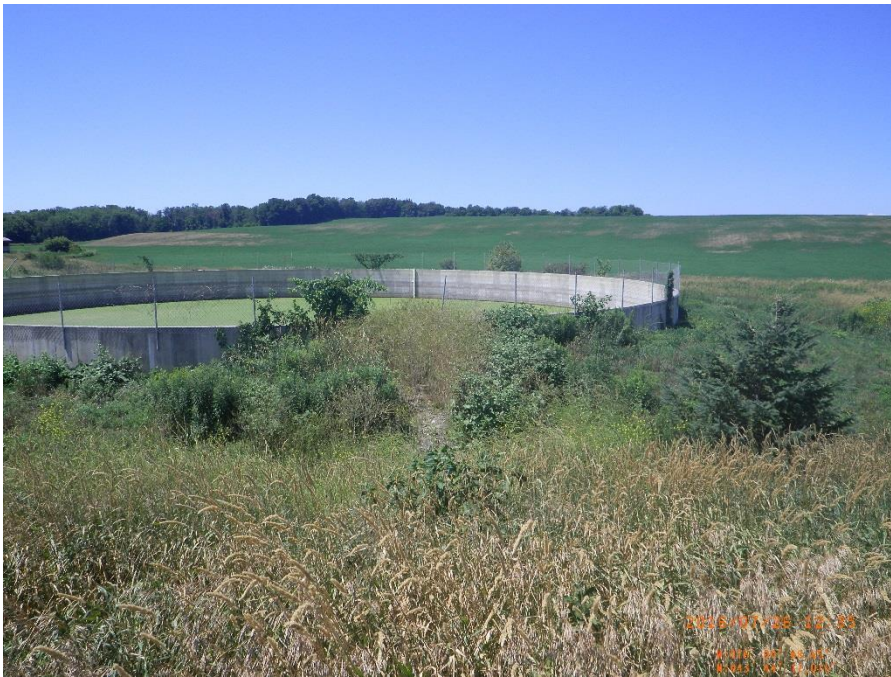
Mr. Eastman stated that the level of leachate in the storage was at approximately 5 feet deep. As previously noted, the storage itself is concrete and has significant vegetation growth around the perimeter in certain areas which may impede access to the storage.

Photo #3 – Excessive vegetation around total silage leachate collection storage; view looking west

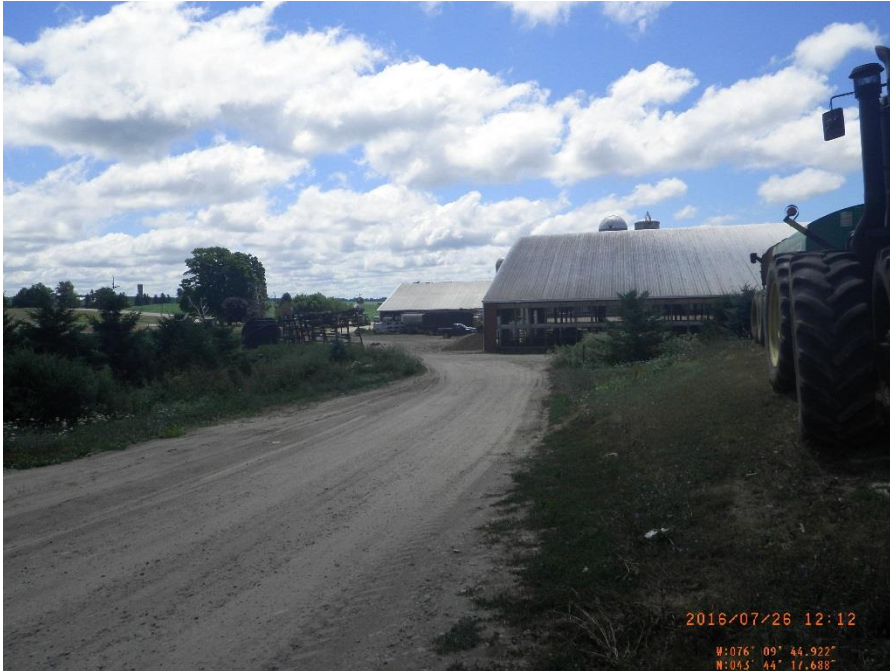
At the time of the inspection, Mr. Eastman stated that the level of manure in the storage was approximately 4 feet. EPA Inspector Arvizu observed a depth marker/max fill marker in the manure storage. In addition, EPA Inspector Arvizu observed that fencing surrounding the storage did not completely surround the storage as three access points were not fenced (south, north, and east). Mr. Eastman explained that the driveway access points were not fenced due to the need for access to the storage by trucks delivering whey to his manure storage. EPA Inspector Arvizu also observed that there were no warning signs indicating the presence of a manure storage.

Photo #4 – Access point from the south, note lack of fencing or gate across the driveway; New and Original Freestall Barns in background

4. During the inspection, EPA Inspector Arvizu observed incomplete fencing around the earthen manure storage as there were three access points that were not gated or fenced. Specifically, the driveway access points (north and south) as well as an access point from the east which appeared to lead to an adjacent corn field were not fenced or gated. As specified in the Safety section of “NRCS Conservation Practice

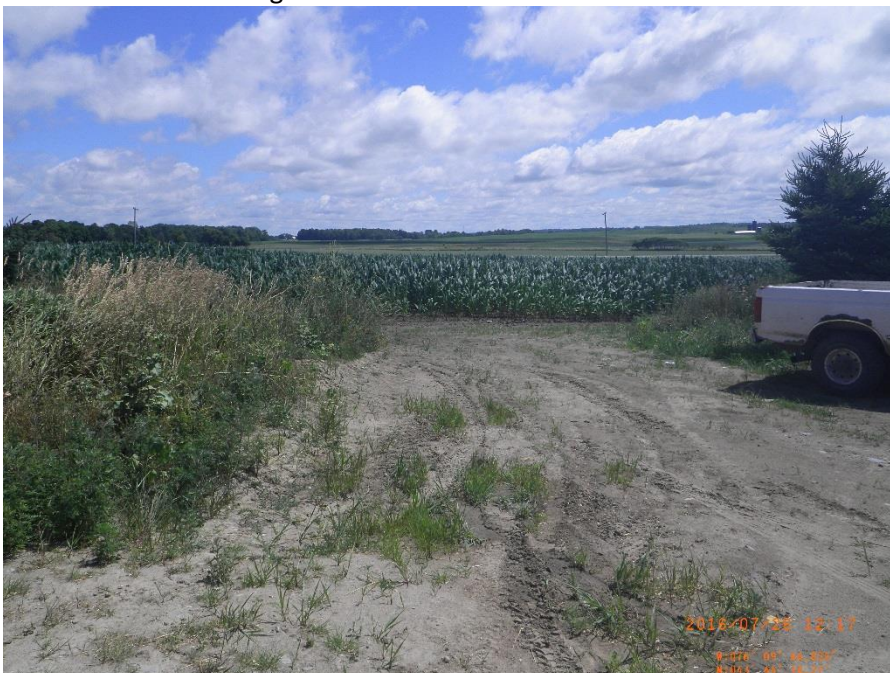
Photo #5 – Access point from the east, adjacent to corn field

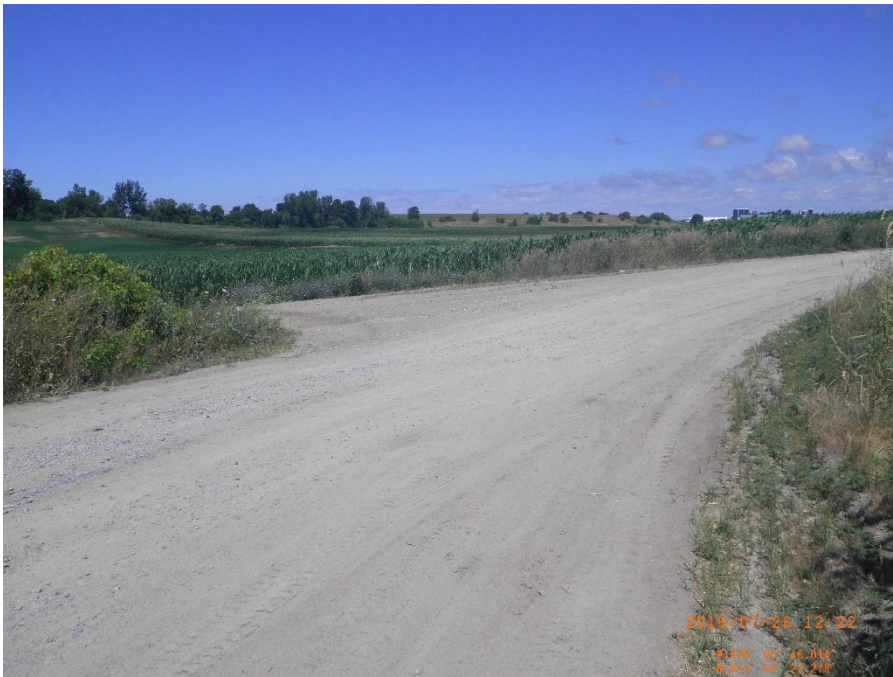
Photo #6 – Access point from the north, note lack of fencing or gate across driveway

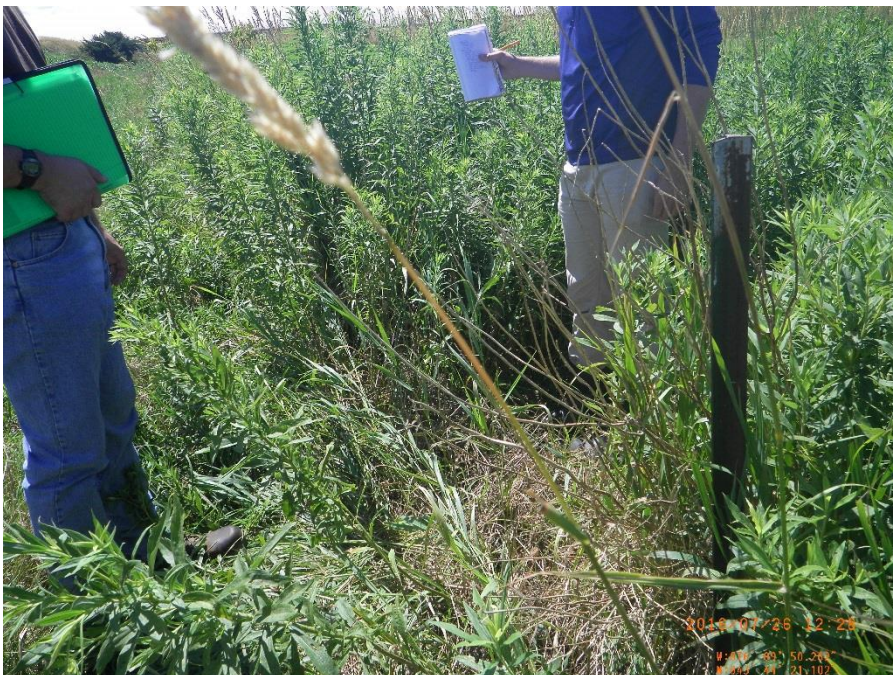
- Fencing in disrepair on the west side of the storage (wire strands were either missing between sections or bunched up at the bottom of the fence posts)
- Overgrown vegetation on the west side of the storage
- (2) Pine trees growing in the berm on the west side of the storage

Photo #7 – Fencing on west side of the storage; wire strands were missing

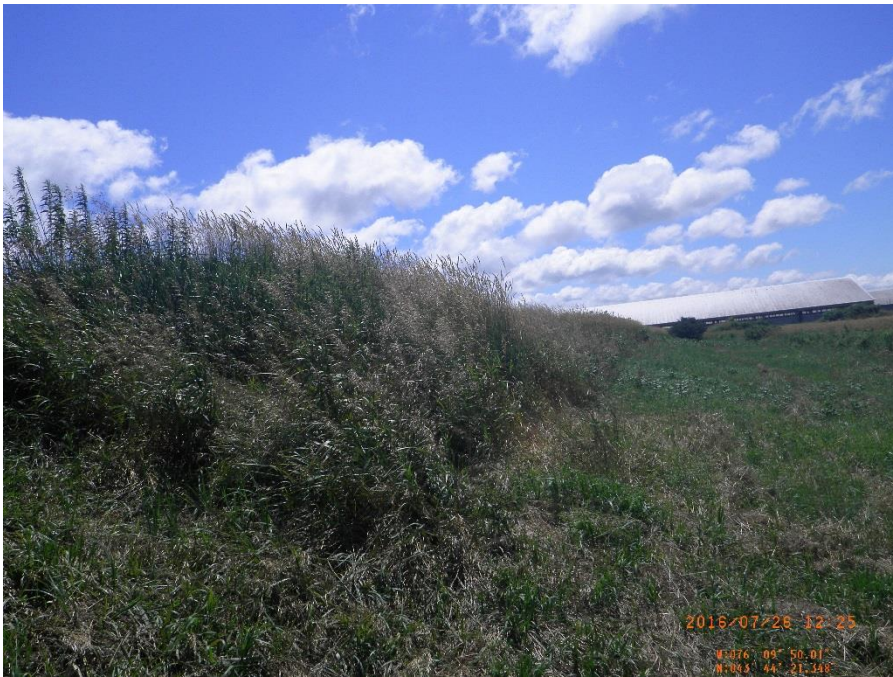
Mr. Eastman stated that it was difficult to mow or brush hog the west side of the manure storage due to the slope of the berm in some areas.

Photo #8 – Overgrown vegetation on the west side of the storage; view looking south

3. Section VIII.C.xi of the NYSDEC CAFO General Permit states that “[c]ollection, storage, and disposal of liquid and solid waste should be managed in accordance with NRCS standards.” NRCS Conservation Practice Standard No. 313 “Waste Storage Facility” specifies general criteria applicable to all waste storage facilities as well as additional criteria for waste storage ponds. During the inspection, EPA Inspector Arvizu observed overgrown vegetation along the west side of the manure storage. In addition, EPA Inspector Arvizu observed two pine trees growing along the berm on the west side of the manure storage.

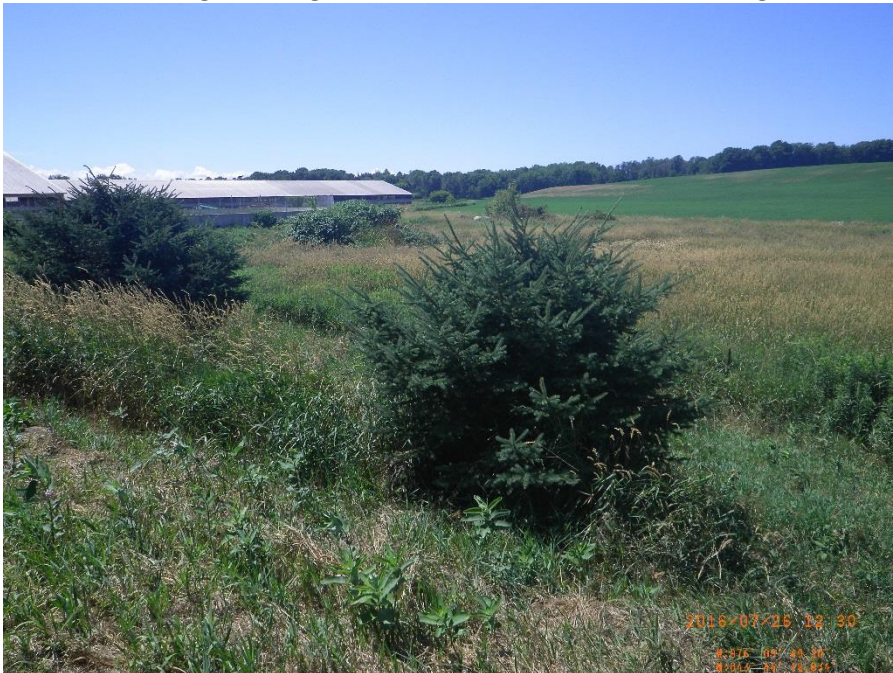
Photo #9 – Pine trees growing on the berm along the west side of manure storage; view looking southwest
